HARBOR HEALTH STUDY

2024

NORWALK HARBOR

Harbor Health Study: 2024

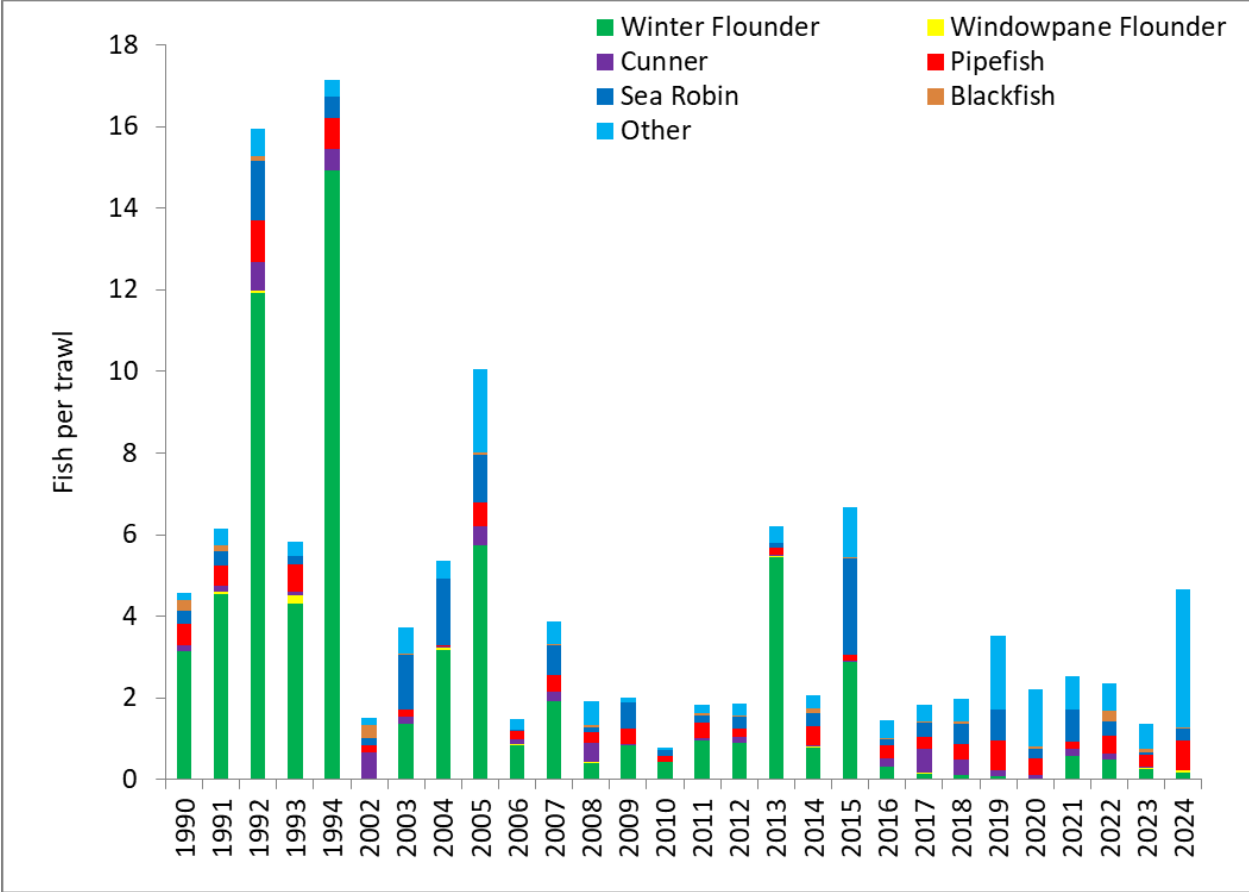
Figure 5.2. Number of fish caught per trawl (total number of individuals divided by total number of trawls) of select species of interest from 1990 to 2024 in Norwalk Harbor.

Over the years that this study has been conducted, there has been slight variance in data collection due to weather patterns, fish kills, boat repairs, occasional requests from the CT DEEP for Harbor Watch to trawl outside of Norwalk Harbor, and a pandemic which disrupted trawling activity. To standardize the data and enable comparisons from year to year, data are reported as "catch per trawl" or the total number of fish caught in a period of time divided by the total number of trawls conducted during that same time period (Figure 5.1, 5.2).

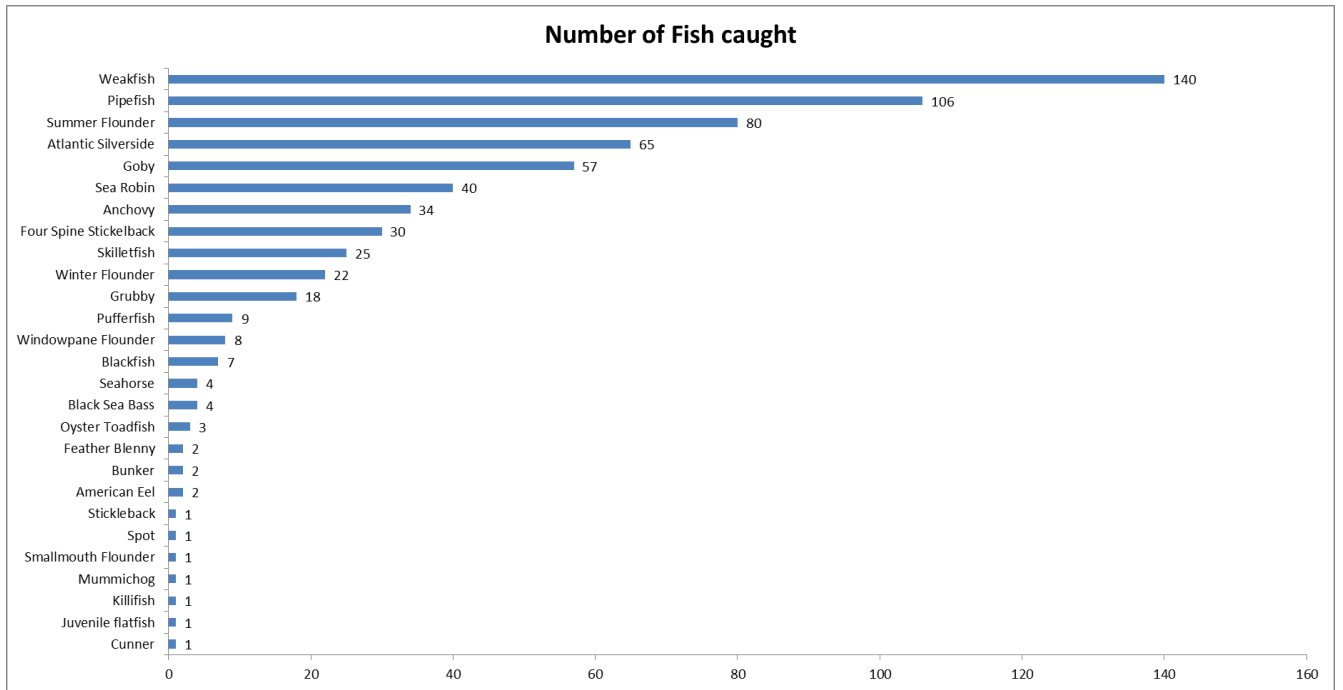
Figure 5.B.1. Total number of individuals caught for each fish species in Norwalk Harbor, February through October 2024.

During 2024, 665 individual fish from 25 different species were caught in Norwalk Harbor (Figure 5.B.1). The 3 most abundant species caught in 2024 were weakfish (*Cynoscion regalis*), pipefish (*Syngnathus spp.*), and summer flounder (*Paralichthys dentatus*), which accounted for 49% of the total number of individuals caught. Fish were observed in all of the 19 boxes sampled (Figure 5.B.2) (no trawls were conducted in Box C due to submarine cables). Box I had the greatest number of fish caught during 2024 with 81 individuals caught in nine trawls. The boxes in the middle harbor had a higher catch per trawl than boxes in the inner and outer harbor (Figure 5.B.3). Overall fish presence in trawls exhibited a significant increase between 2023 and 2024. In 2023, 45% of trawls resulted in no fish presence; however, in 2024, this figure decreased to 17% (Figure 5.B.4). While sampling was typically conducted in the upper, middle, and outer harbor during each trawling trip, tidal cycles impeded access to particular boxes (Table 5.B.1).

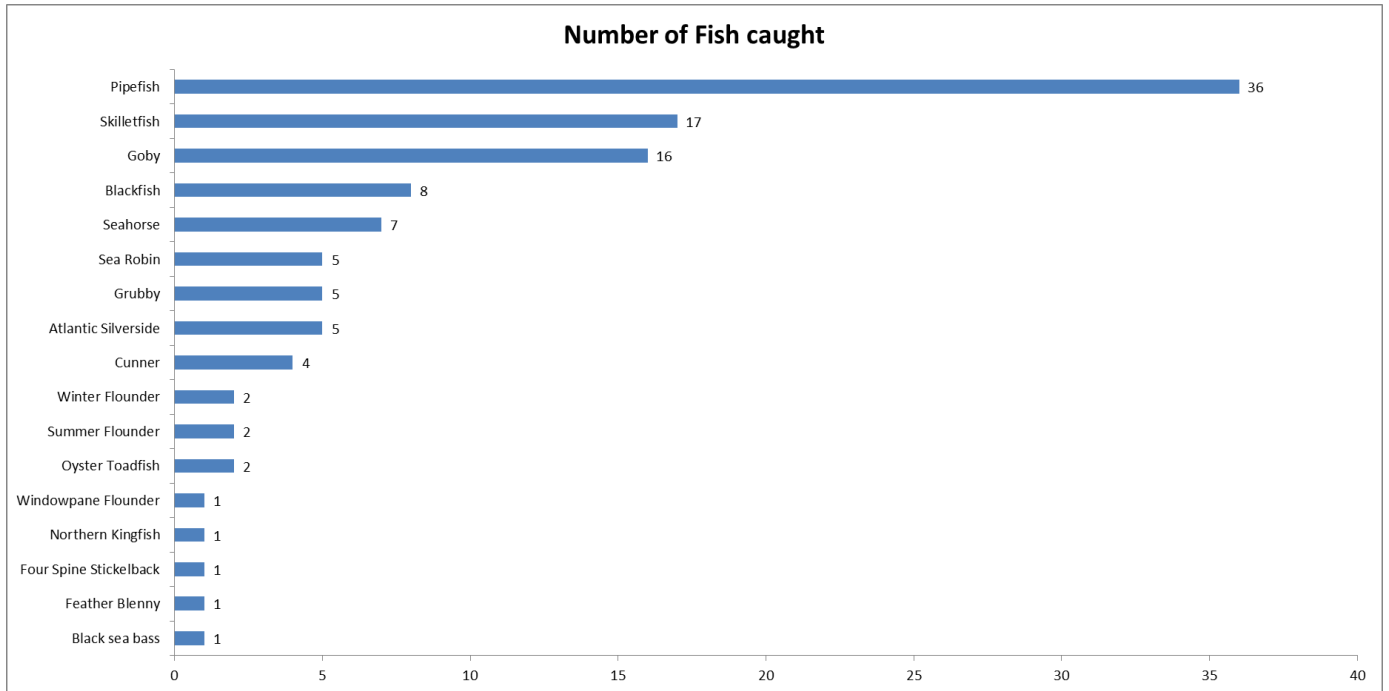
Figure 5.C.1. Total number of individuals caught for each fish species in Saugatuck Harbor, May through September 2024.

During the 2024 sampling season, 114 individual fish from 17 different species were caught in Saugatuck Harbor (Figure 5.C.1). The 3 most abundant species caught in 2024 were pipefish (*Syngnathus spp.*), skillettfish (*Gobiesox strumosus*), and goby (*Gobiosoma spp.*), which accounted for 61% of the total number of individuals. Fish were observed in 17 of the 22 boxes sampled (Figure 5.C.2). Box I had the greatest number of fish caught during 2024 with 26 individuals caught in three trawls. The number of fish caught per trawl in each box varied throughout the harbor with boxes I and K having the highest abundance (Figure 5.C.3). No trawls were conducted in boxes A and C due to height restrictions at a bridge crossing and submarine cables, respectively. While sampling was typically conducted in the upper, middle, and outer harbor during each trawling trip, tidal cycles impeded access to particular boxes (Table 5.C.1).

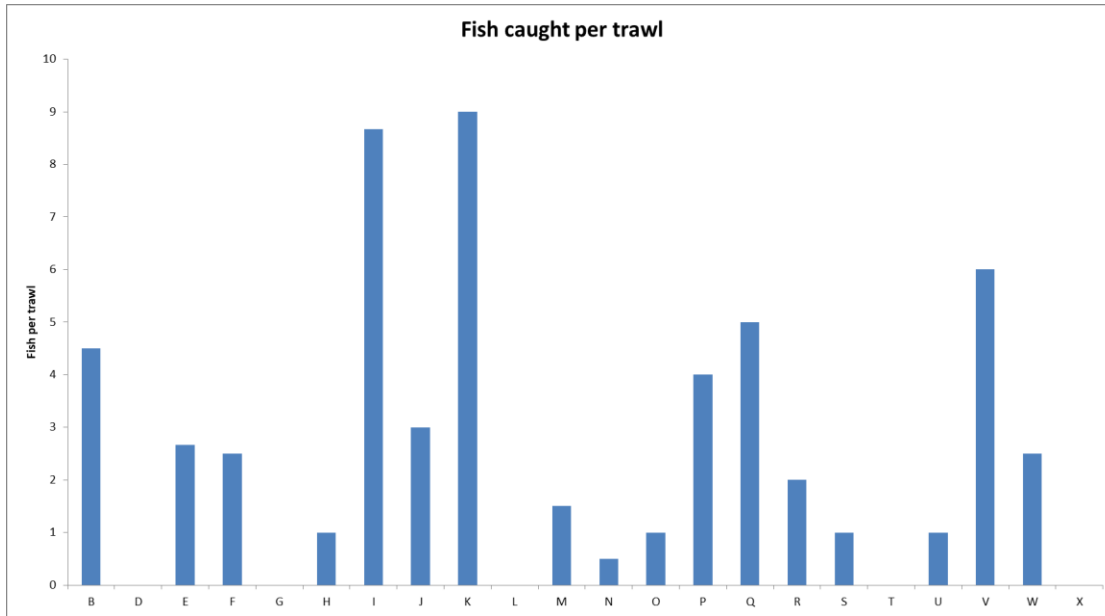
Figure 5.C.3. Number of fish caught per trawl (total number of individuals divided by total number of trawls) in Saugatuck Harbor for each box trawled in 2024.

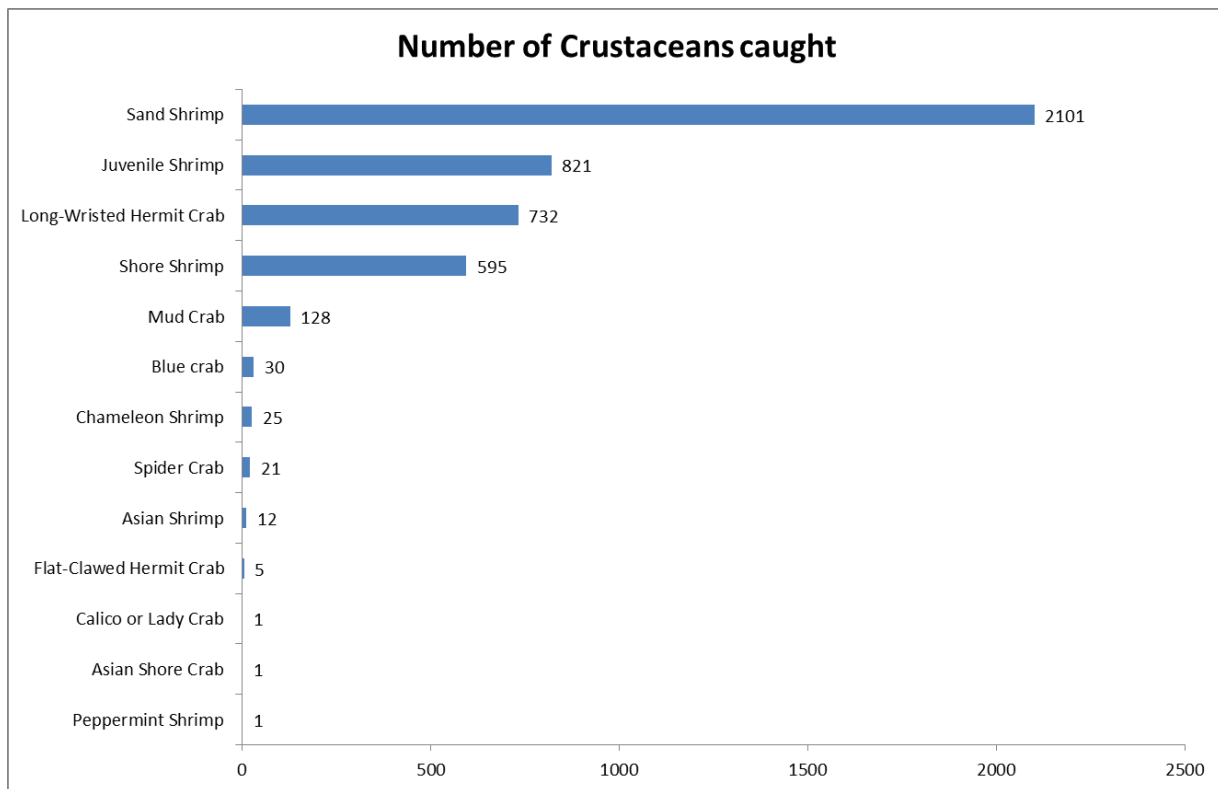
Figure 5.C.3. Crustaceans caught in Saugatuck Harbor from May through September 2024.

In 2024, 4,473 individual crustaceans representing 12 species were observed. Certain individual shrimp were too small to identify confidently and therefore were documented as “Juvenile Shrimp.” The catch was dominated by sand shrimp (*Crangon septemspinosa*), juvenile shrimp, and long-wristed hermit crab (*Pagurus longicarpus*), accounting for approximately 82% of the total (Figure 5.C.3). Individual speciation for mud crabs and spider crabs was not conducted. The “Mud Crab” identification represents potentially four species (*Panopeus herbsti*, *Hexapanopeus angustifrons*, *Neopanopeus sayi*, and *Eurypanopeus depressus*) but was likely dominated by black fingered mud crab (*Panopeus herbsti*). The “Spider Crab” identification represents potentially 2 species (*Libinia emarginata* and *Libinia dubia*) but was likely dominated by the nine-spined spider crab (*Libinia emarginata*). Other notable catches include five different species of shrimp, 2 of which are nonnative (Asian shrimp, *Palaemon macrodactylus*, and Peppermint shrimp, *Lysmata spp.*). Nonnative species were documented and shared with CT DEEP for identification confirmation and to be used in assessing the impacts of these species on the native populations.

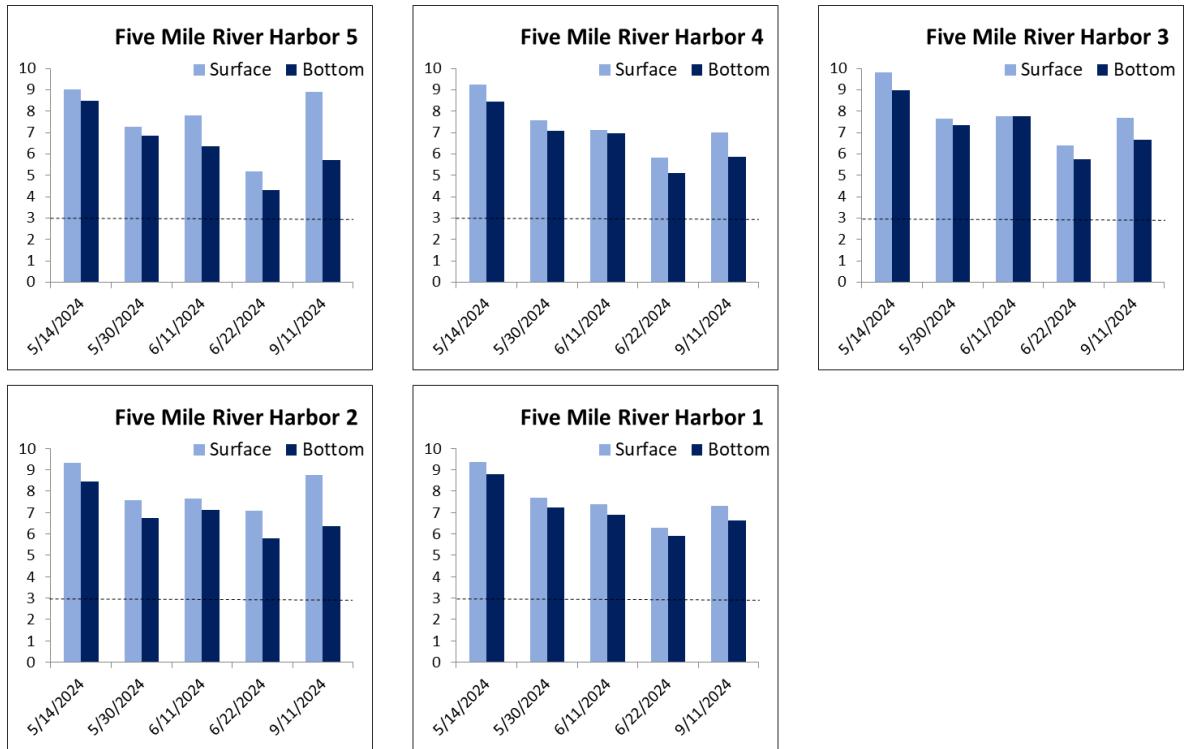
Figure 7.A.3. Surface and bottom dissolved oxygen values at each Five Mile River Harbor sampling station on each monitoring date during the 2024 season. The dotted line represents hypoxic conditions (3 mg/L). Please note x-axis is individual sampling dates, not a time scale.

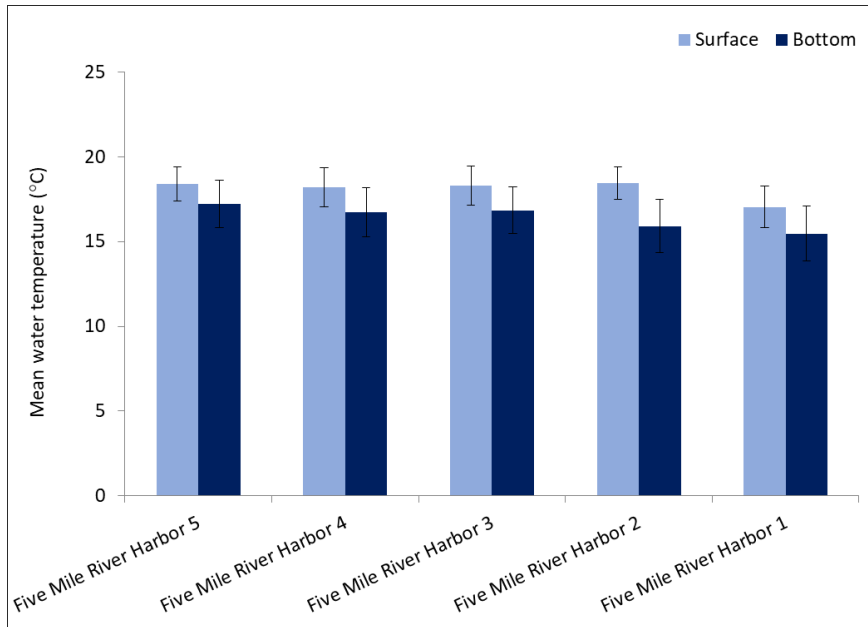
Figure 7.A.4. Mean water temperature at the surface and bottom at each sampling station in Five Mile River Harbor in 2024. Error bars represent standard error.

Mean surface and bottom water temperatures in Five Mile River Harbor were similar throughout the harbor (Figure 7.A.4). Lower salinity observed at the surface in the landward end of the estuary reflects the impact of Five Mile River input from the north and Indian Creek input upstream of Five Mile River Harbor 5, where the harbor is less well mixed (Figure 7.A.1, Figure 7.A.5).

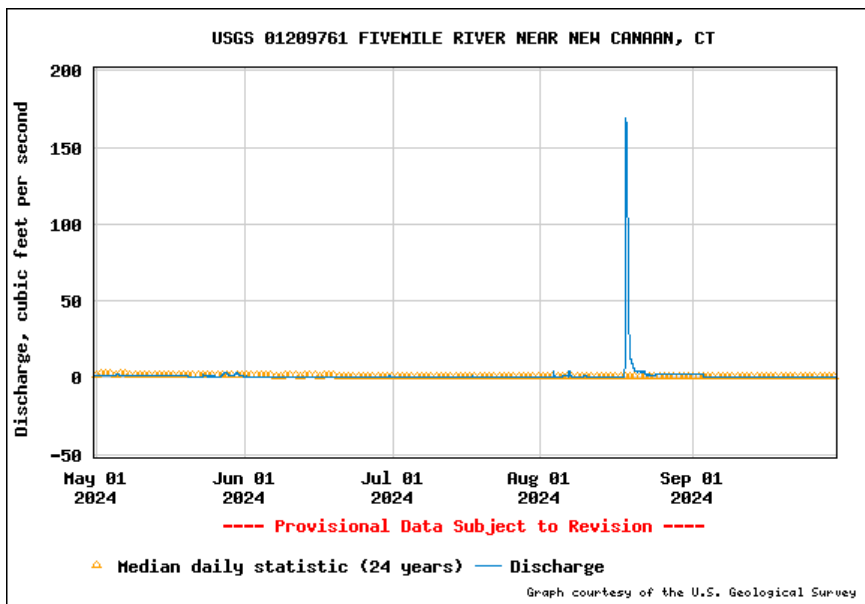
(c) **Figure 7.A.7.** USGS flow data in ft^3/s for the period of (a) May 1 through September 30, 2023, (b) May 1 through September 30, 2024, and (c) May 1 to August 17, 2024 respectively for the Five Mile River in New Canaan, CT (Graph courtesy of the U.S. Geological Survey). Please note the difference in scale on the y-axis.

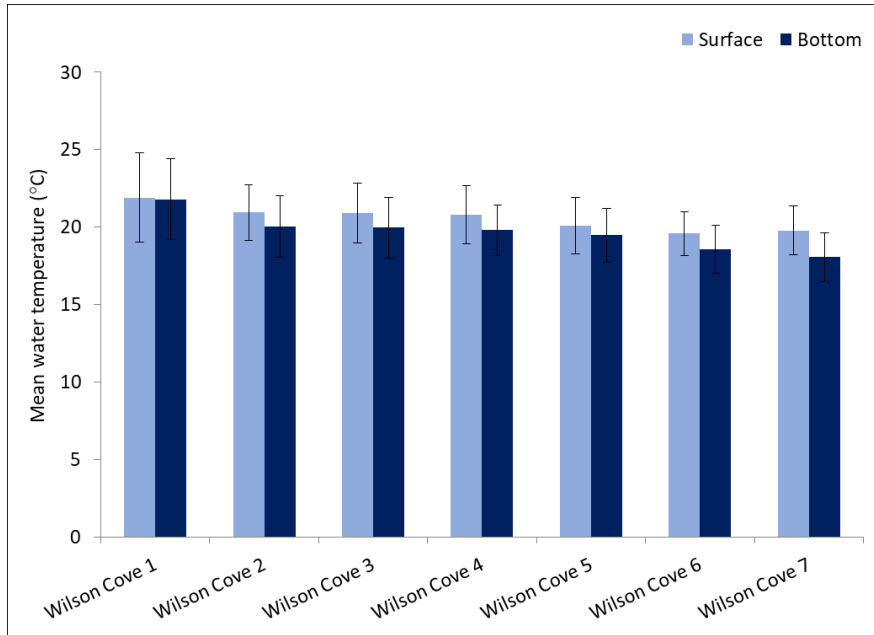
Figure 7.B.4. Mean water temperature at the surface and bottom at each sampling station in Wilson Cove in 2024. Error bars represent standard error.

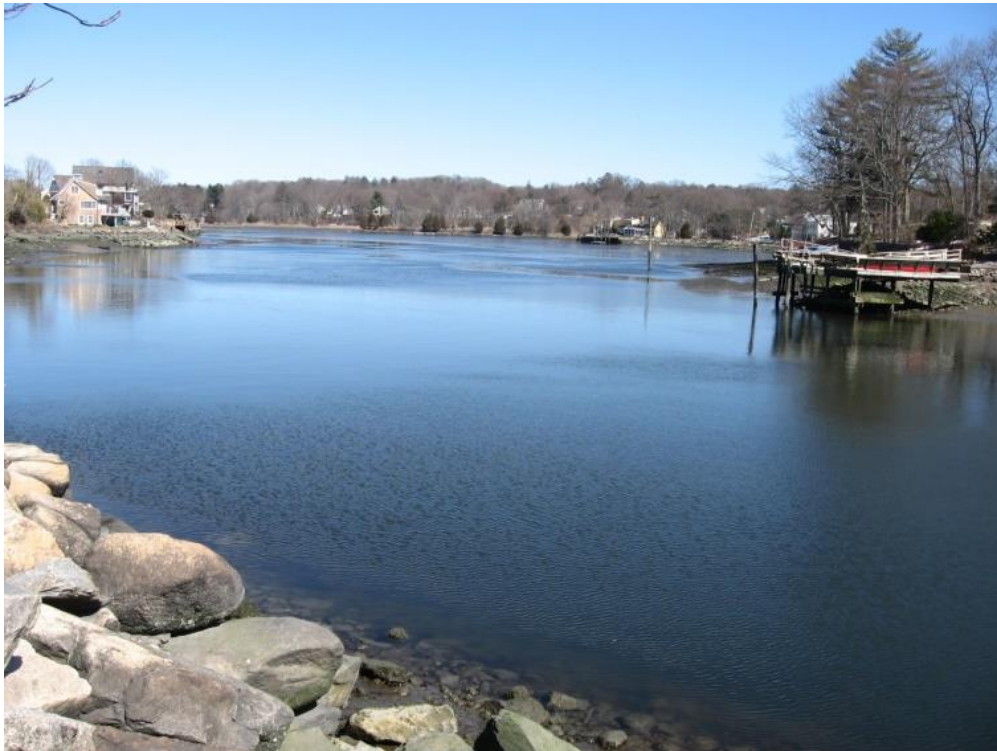
Figure 7.D.1. Looking upstream at the first basin from Saugatuck Harbor 6.

Situated at the mouth of the Saugatuck River, Saugatuck Harbor is approximately 3 miles long and relatively narrow with the exception of 2 basins. The first of these is a large basin located just to the north of station Saugatuck Harbor 6 (Figure 7.D.1, Figure 7.D.2). The second smaller basin is located just to the north of station Saugatuck Harbor 4 (Figure 7.D.2). The combined effect of these basins on ebb tide provides a strong flushing current for the estuary. The estuary then broadens into a wide but shallow harbor just to the south of station Saugatuck Harbor 3 (Figure 7.D.2). The land area on both sides of the upper estuary and the main harbor is mostly developed. The commercial area of the Town of Westport borders the northeastern side of the harbor above the Route 1 bridge. From this point moving southward the east bank of the harbor is residential up to the Longshore Country Club area and the Compo Boat Basin Marina. The west bank of the harbor is developed with a mixture of commercial businesses including a rowing club and a few small marinas. The Saugatuck Shores area on the western bank of Saugatuck Harbor is developed with single-family homes and 2 yacht clubs. Some salt marshes are present along the harbor margins south of the Canal Street bridge and just to the north of the I-95 bridge. Much of the shoreline has been filled for development but several large strip marshes are also still present along the western bank as the harbor opens into a larger basin near the mouth (Figure 7.D.2).

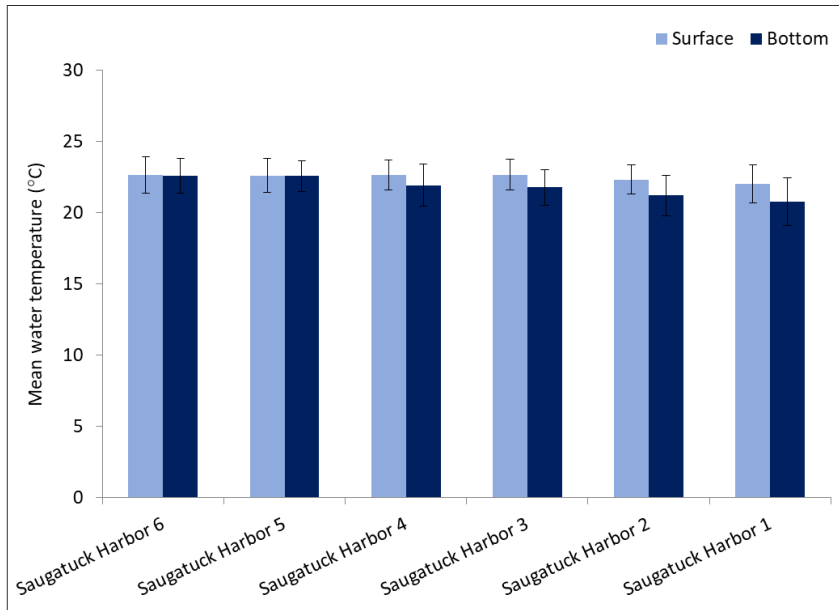
Figure 7.D.5. Mean water temperature at the surface and bottom at each sampling station in Saugatuck Harbor in 2024. Error bars represent standard error.

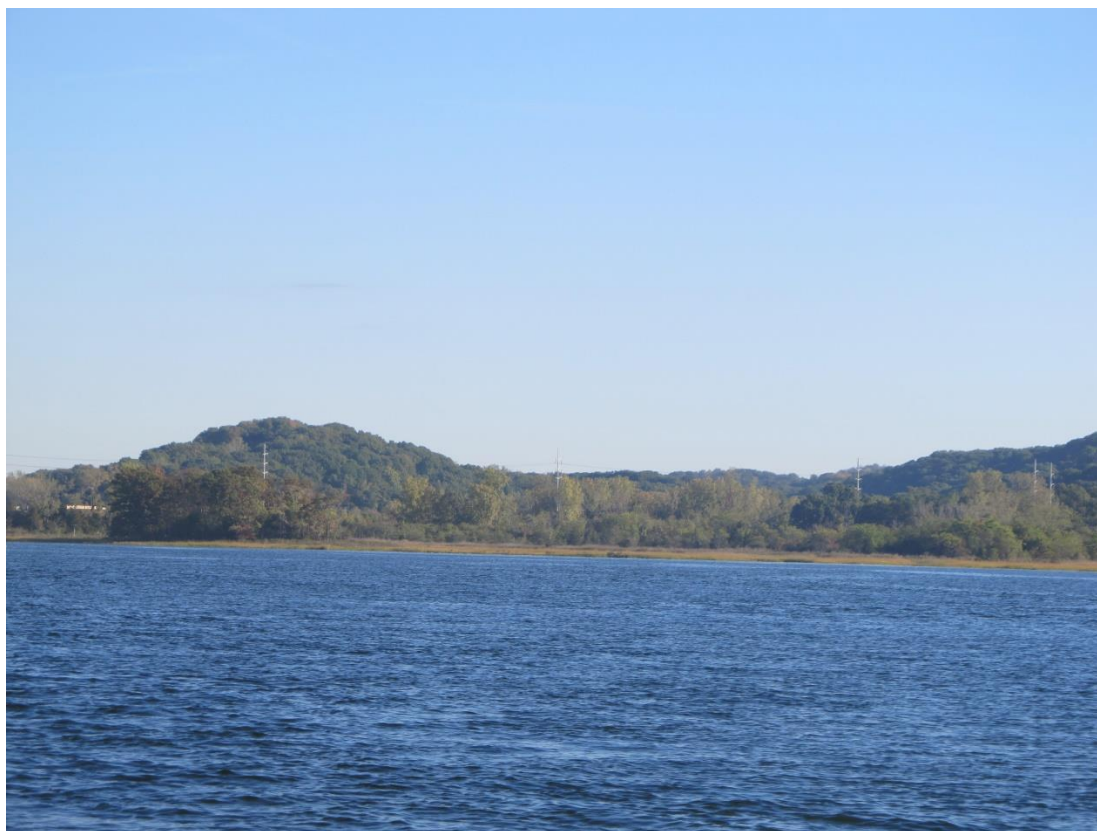
Figure 7.F.1. View of the large flushing basin in New Haven Harbor with extensive wetlands on the eastern shore.

New Haven Harbor is an important estuary for the shellfish industry because it is a spawning ground for oysters. The Quinnipiac River supplies the fresh water flow at the northern end of the estuary, meeting the harbor near the I-91 bridge. The southern end of the estuary widens to a broad but shallow embayment south of the Ferry Street Bridge. The constricted area at the lower end of the basin (station Quinnipiac River 4) provides excellent tidal flushing for the whole basin on an ebb tide. The upper portion of the estuary between the Ferry Street bridge and the I-91 bridge was studied for this water quality survey. Approximately 1.5 miles long by 0.25 miles wide, this portion of the estuary is a semi-enclosed basin. A protected wetland, the 35-acre Quinnipiac Meadows - Eugene B. Fargeorge Preserve, is located on the eastern shoreline along the upper portion of the estuary (Figure 7.F.1). The lower portion on the eastern shore, south of the Grand Avenue Bridge, is occupied by Copps Island Oysters harvesting facility, an oil terminal, and a barge refurbishing company. The land use on the western shore includes a marina and residential areas. The area south of the Grand Avenue Bridge is navigable by large vessels while the area north of the bridge becomes very shallow at low tide and is navigable only by small boats. Due to these shallow waters and prevailing fast currents, monitoring could only occur during slack high tides.
